## **Condition Assessment of Building 6237, Old Hospital Complex, Fort Carson, CO**

by Thomas R. Napier and Sheila A. McCarthy

August 2000

ERDC/CERL TR-00-24

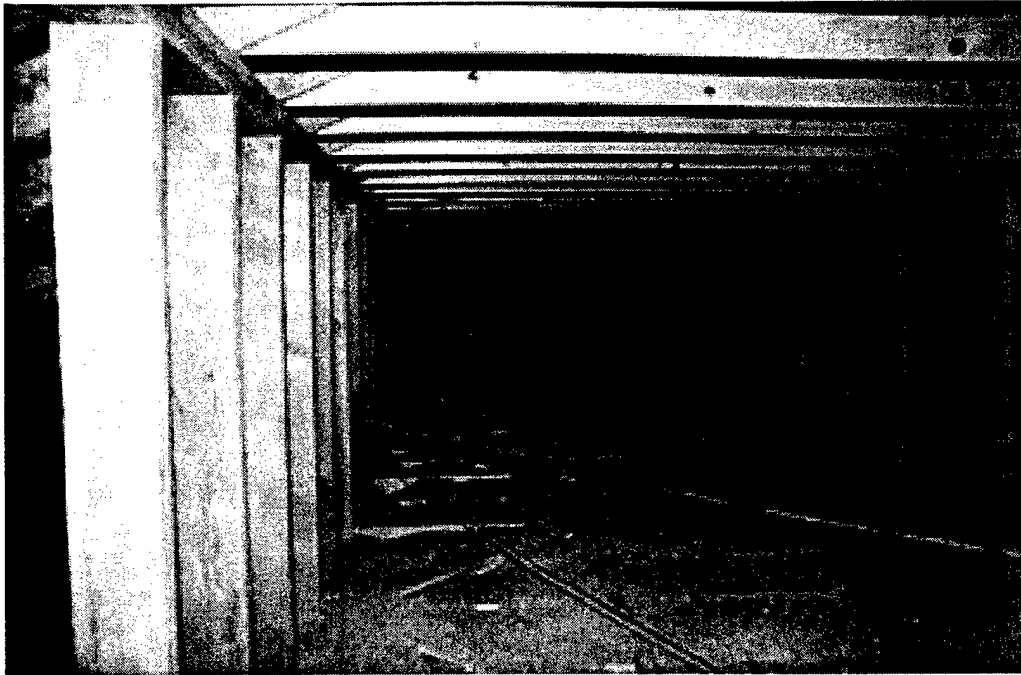
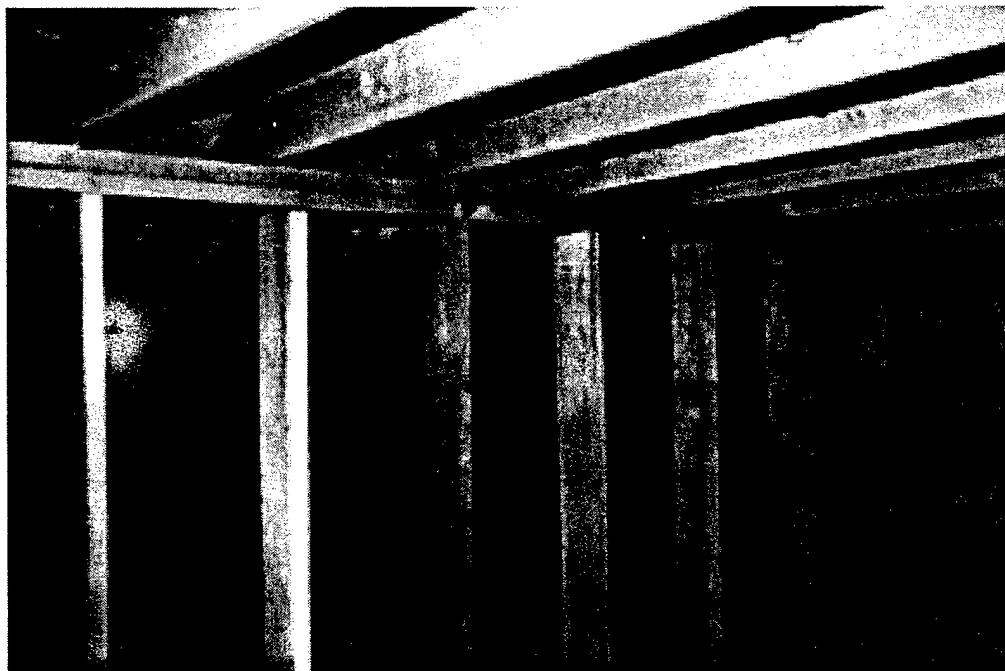
When viewed from below (from the attic spaces), the roof framing system appeared to be straight and true (Figures 3-14 and 3-15). Rafters were generally free from checks and knots. Pencil marks were observed, presumably made during construction, and members were still aligned with the marks. Structural members and sheathing appeared to be clean, with no evidence of water damage, or even staining. The bottom edges of rafters, in all locations, were aligned, with no saddles or sagging observable. There was no visible nail pulling, splitting, dislocation, or other sign of distress to suggest excessive uplifting at the eaves. Ridge boards were level and straight. The only irregularity observed in ridge boards was due to the slightly different dimensions of each individual 2 X 8. Knee walls were plumb, with no dislocation observed. Several ceiling joists were tested for level in several locations within each building bay. Some cracking was observed in ceiling surfaces (see "Ceiling Finishes" under Interior Construction). The joists above, however, were found to be level, with no signs of deflection or deformation.

Figure 3-14. Roof framing — rafters and knee walls.

Figure 3-15. Roof framing — view of knee walls.
